Memo

To: Board of Managers
From: Michael Younes, Director of Municipal Operations *[Signature]*
CC: Shana Davis-Cook, Village Manager
Date: 6/6/2013
Re: Village Sidewalk Replacements

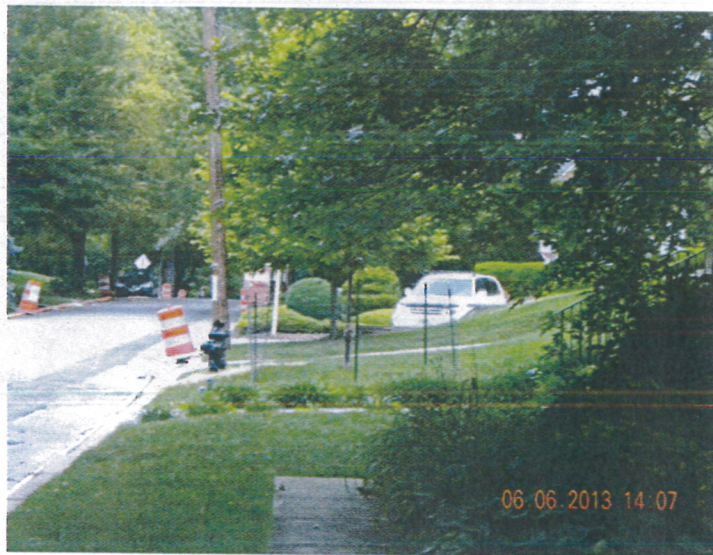
- a. Grove Street (between Kirkside Drive and Cedar Parkway): Currently, there is a concrete sidewalk that extends about 190 feet north of the Kirkside Drive intersection. If this section were to be extended there would be significant private hardscaping (i.e., walkways, fences and walls, etc.) and mature tree (Village and private) impacts.

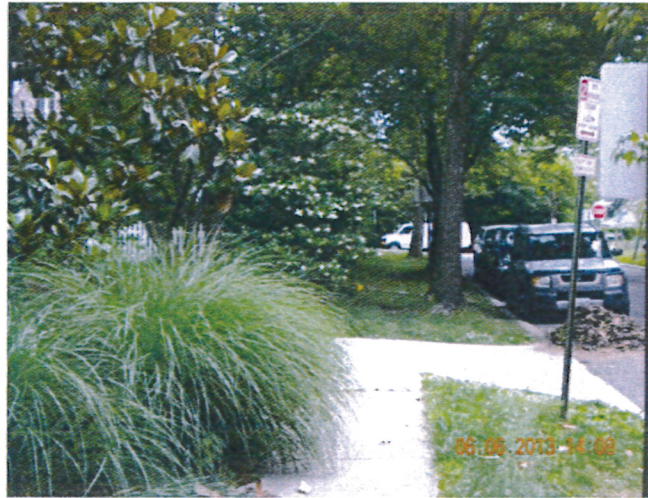
- b. Kirkside Drive (between Grove Street and Western Avenue): Currently there is a concrete sidewalk that extends for half of the block. This section could be extended to connect with the existing sidewalk located at Western Avenue without any major impacts to trees or privately-installed features.

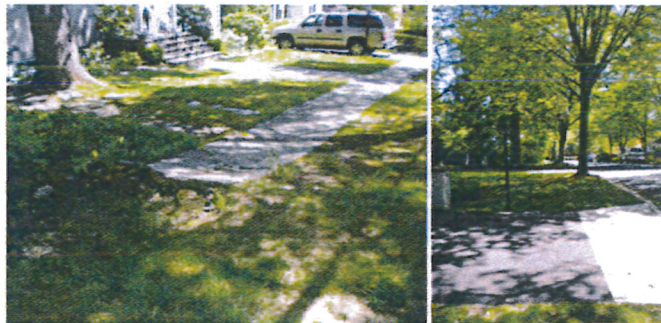
- c. East Lenox Street (between Nevada Avenue and Brookville Road): Staff has already recommended that this section be extended to connect with the Brookville Road sidewalk. A petition from the majority of residents on the block has already been received in support of the extension.

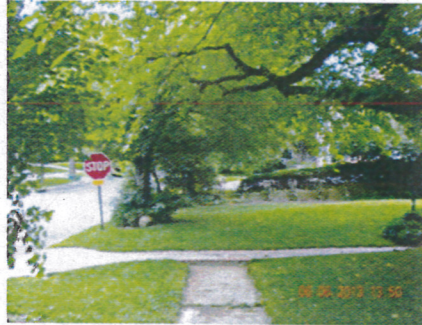
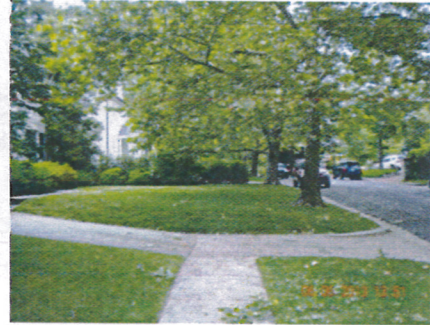
- d. East Melrose Street (between Brookville Road and the East Melrose Circle): There is currently a concrete sidewalk located within a portion of the East Melrose Circle and south side of East Melrose Street. If these sections were to be extended to connect with the Brookville Road sidewalk there would be significant private hardscaping (i.e., walkways, fences and walls, etc.) and mature tree (Village and private) impacts.

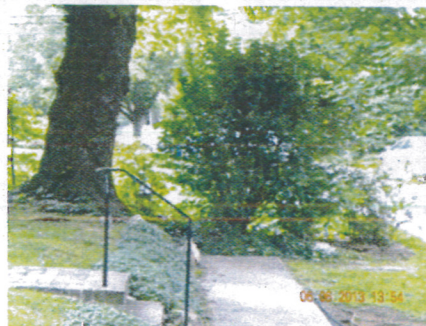
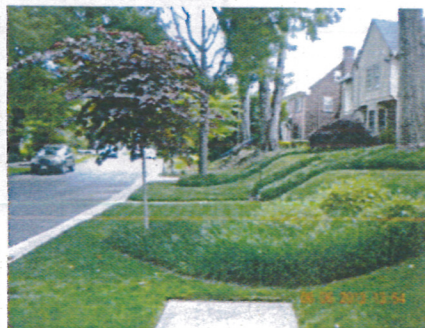
- e. Summerfield Road: There are currently sections of brick and concrete sidewalk located on both sides of Summerfield Road beginning at Oxford Street and extending half way along both sides of the block. It would be possible to extend the sidewalk on the odd side of the street without significant impacts. The even side of the street would be greatly impacted by extending the sidewalk. A few residents have voiced their concerns and have stated that they would prefer that the existing sidewalks were instead removed along their side of the street. It is worth noting that if extended, the sidewalks would dead-end at Western Avenue where there are no sidewalks.

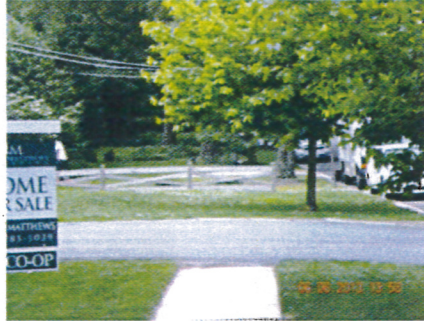
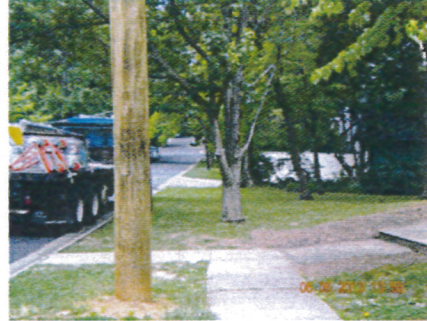
- f. Primrose Street (between Brookville Road and Oxford Street): There is currently a concrete sidewalk that runs from Brookville Road to a point approximately half the distance toward Oxford Street along both sides of the street. It would be possible to extend the sidewalk on the even side of the street without significant impacts. Mature trees on the odd side of the street would be negatively impacted by extending the sidewalk.

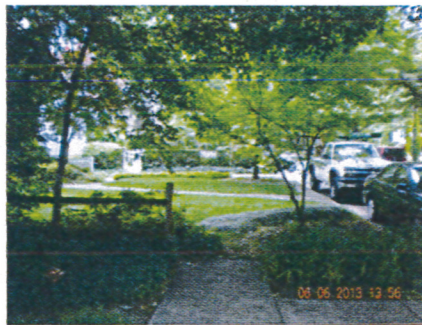
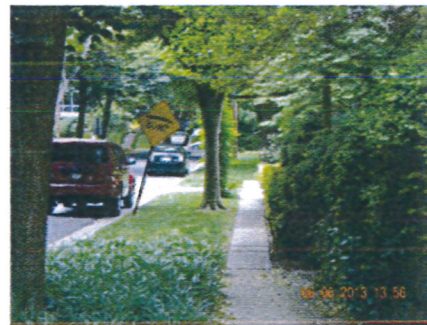
- g. Primrose Street (between Oxford Street and Western Avenue): Currently, there is a concrete sidewalk that runs from Oxford Street to a point approximately half the distance toward Western Avenue along both sides of Primrose Street. If these sections were to be extended there would be significant private landscaping and mature tree (Village and private) impacts. It is worth noting that if extended the sidewalks would dead-end at Western Avenue where there are no sidewalks.
